Category 1 (Projects over A\$1 million)

Tunks Park Aqueduct by Metropolitan Restorations

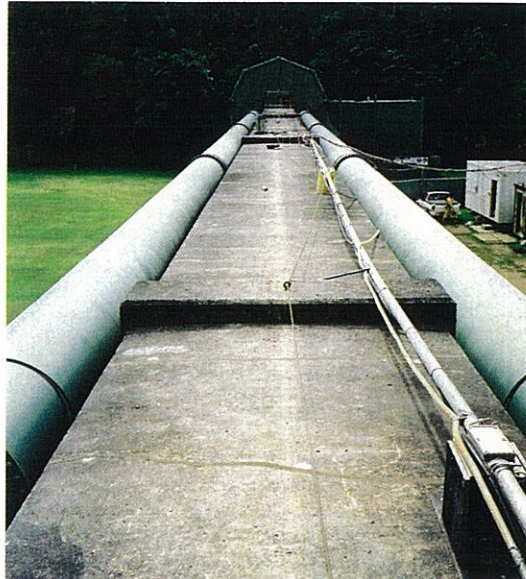
A diversion pipeline was built and installed to maintain the systems' continued use during repair works.

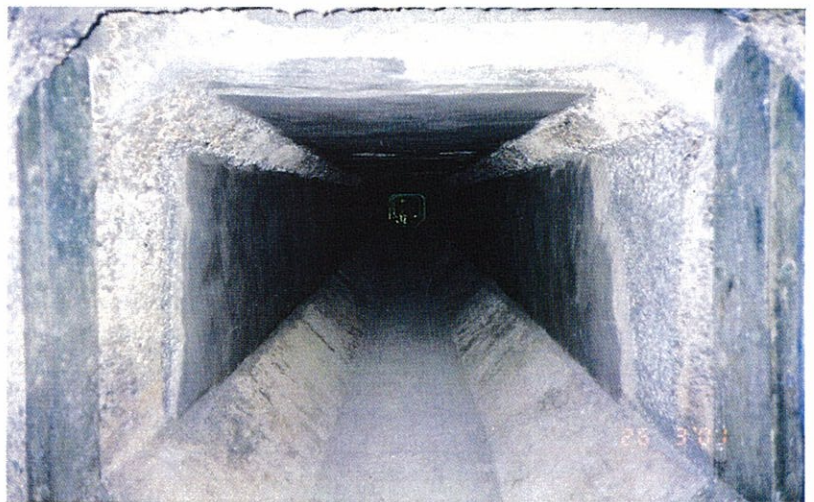
Application of 3 pack epoxy mortar to all internal surfaces with areas sectioned off.

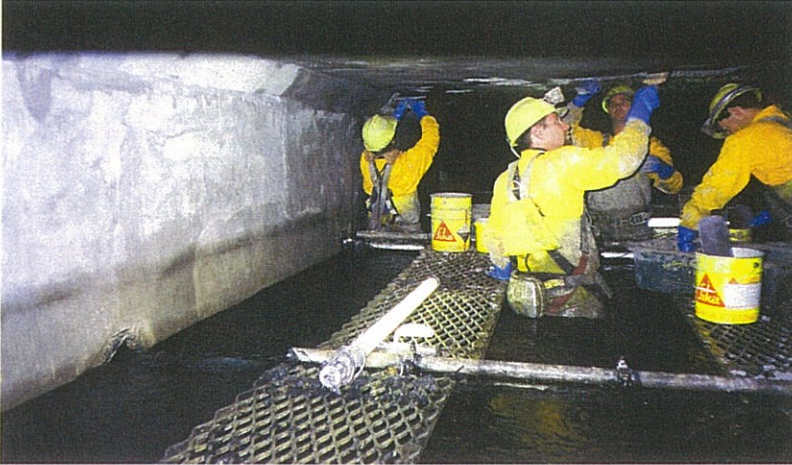
Application of 20 mm thick protective layer of hand applied 3 pack epoxy system under extreme work conditions.
