Hurstville Sewer Reline

Sika in the Sewer

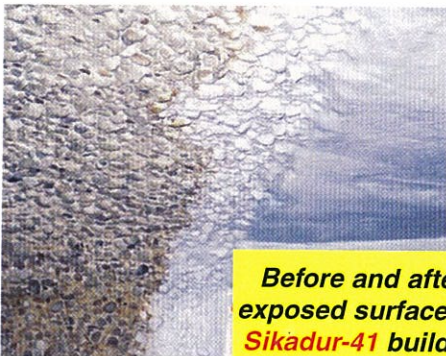
The re-lining of the Hurstville Sewer was one of the largest repair specifications for sewer lines put together by Sydney Water. Major concrete spalling and badly deteriorated surfaces throughout

Before and after -
exposed surface and
Sikadur-41 build up.

the 160 metre long x 3.5 metre wide x 1.5 metre high tunnel meant intense blasting and cleaning was required to prepare the substance for repair. **Metropolitan Restorations** were called upon to do the repair, which included the following:

- Repairs using **Sika MonoTop[®] -610** as a protective coating to the exposed steel and as a bonding bridge for the polymer modified repair mortar **Sika MonoTop[®] -615HB**.

- Relining using **Sikadur-32** as a prime coat for the epoxy mortar **Sikadur-41**. This was applied as a 20mm render coat around the sewer line wall. Once in place the render was covered with the protective coating **Sikagard-62**, to ensure maximum protection.

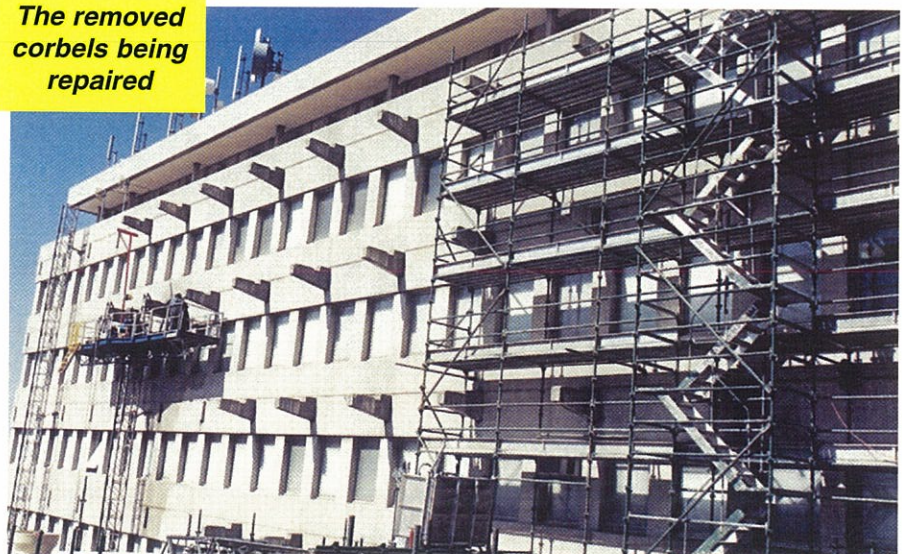
Wollongong Hospital Repairs

The removed
corbels being
repaired

As part of a large refurbishment project, the Wollongong Hospital, located south of Sydney, required a typical concrete repair system to reinstate areas that spalled or were showing signs of deterioration. **Metropolitan Restorations** were asked to apply the Sika concrete repair system to areas that had the building corbels removed. Any exposed steel was cleaned and protected with **Sika MonoTop[®] -610**. This material was also used to prime the concrete area surrounding the steel, before the **Sika MonoTop[®] -615HB** patch repair mortar was applied to fill the cut out areas. Where rusted bars were removed, new starter bars were installed using the quick setting **Sika PowerFix[®] -1** anchoring adhesive.

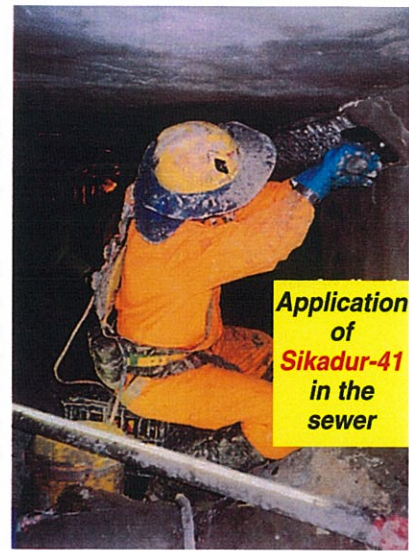
Metropolitan Restorations were contracted by the AWT in Sydney to repair the Tunks Park aqueduct in Northbridge after many years of aggressive behaviour from within. The concrete had degraded due to carbonation and the constant flow of water containing aggressive materials. As a result, the concrete was losing its alkalinity, thus exposing the steel reinforcement to damage.

The repair work involved the contractor and specifier "thinking outside the square". Due to constant flow and moisture within the aqueduct, **Sika Plug**, a temporary water stop, was used in conjunction with **SikaSwell** swellable sealant, to patch and fill many areas, to allow repair work to continue. Repairs were generally completed using the bonding bridge **Sikadur-32** along with **Sikadur-41** epoxy repair mortar. The internal walls were then coated with **Sikaguard-62**, a protective epoxy coating. Any external repairs were completed using the **Sika MonoTop** polymer modified cementitious repair system.

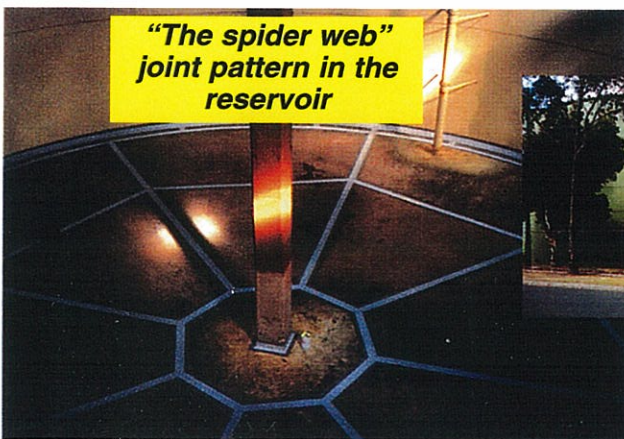
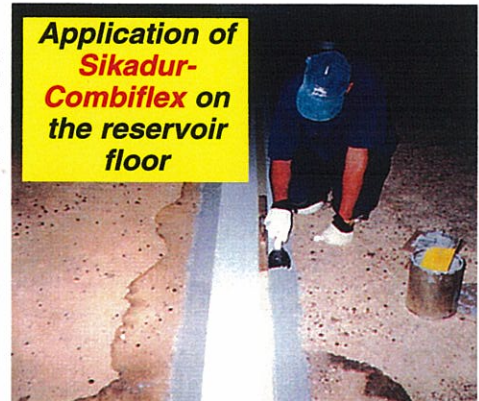
South Windsor Reservoir

Keeping water reservoirs watertight is an integral part of any design and maintenance of such structures. Waterproof coatings or joint systems are used to ensure that this level of watertightness is maintained. Recently, the South Windsor reservoir in western Sydney required an overhaul of its existing joint system. The AWT, after careful inspection and analysis, realised the need for a new joint system. **Metropolitan Restorations** were contracted to replace the existing joints with the flexible **Sikadur-Combiflex** system.

Sikadur-Combiflex is a combination of flexible hypalon PVC sheeting, held in place by the epoxy

adhesive **Sikadur-31**. The system was being placed over the spider web patterned floor joints, and around the floor to wall joint. The existing sealant in the floor joints was initially removed, and replaced with **Sikadur-PRO 2HP**, which acted as a cushion for the hypalon sheeting. The **Sikadur-Combiflex** was then applied on the prepared substrate.

The floor to wall joint required some special attention. The wall, made of steel, needed to be sand blasted to remove all traces of contaminant.

The wall was then coated with **Sikadur-32** bonding agent, blinded with sand, and allowed to cure, giving the **Sikadur-31** adhesive an excellent key to bond to.

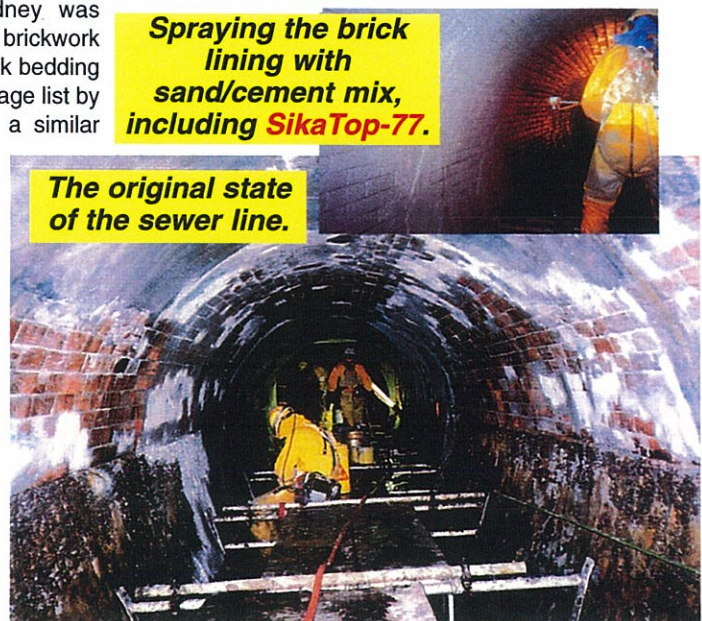
The sewer line found underneath Blair Street, Bondi, Sydney was constructed over 70 years ago using brickwork. In some areas the brickwork had eroded due to severe decay, resulting in a breakdown of the brick bedding mortar. Some sections of the sewer line had been placed on the heritage list by the Heritage Council, and as such, repair work had to result in a similar appearance.

Spraying the brick lining with sand/cement mix, including **SikaTop-77**.

The brickwork bedding mortar was reinstated using a sand/cement mix that included **SikaTop-77** polymer admixture. The **SikaTop-77** was added to improve workability and watertightness. Spraying a sand/cement mix with **SikaTop-77**, at a different ratio to the bedding mortar repaired the large patches. The mortar was sprayed on to adhere loose bricks, and to achieve bulk patching in those sections of the sewer line. Finally, some sections of the sewer line required re-profiling. The lining in the lower sections of the tunnel and chamber was re-profiled using the epoxy repair products **Sikadur-31/41** to patch and level out the tunnel, before a protective coating of **Sikagard-62** was applied.
